## **URGENT MEDICAL DEVICE CORRECTION** **Percepta™ CRT-P MRI SureScan™ and** **Percepta™ Quad CRT-P MRI SureScan™ Pacemakers**

Model	Geography
W1TR01	US
W4TR01	US
W1TR04	OUS
W4TR04	OUS

June 2018

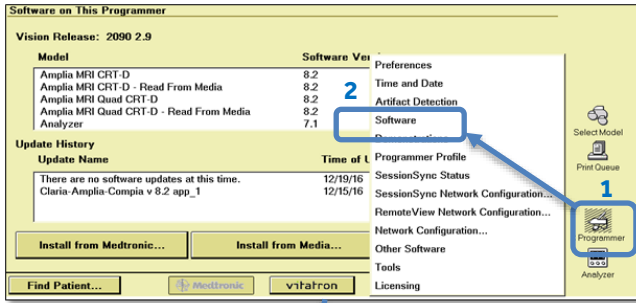
**APPENDIX A**  
**PROGRAMMER USER SCREENS**  
**Software Installation History Screen**  
**Image 1a**

- Ensure the programmer has been updated to Percepta Application Software "Version 8.1" by viewing the software installation history under the Programmer Icon; Refer to Image 1a and 1b in Appendix A.

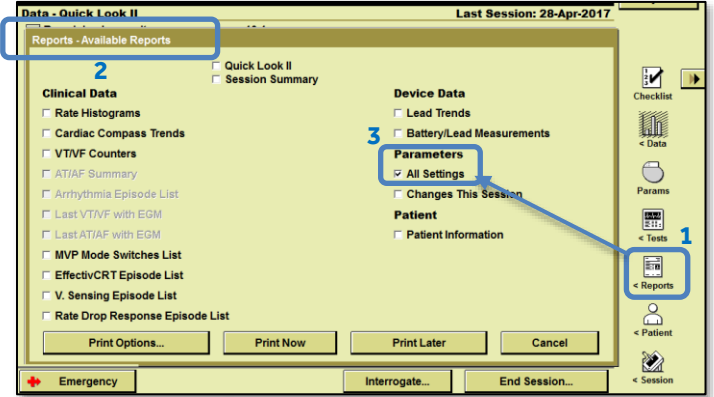
**Parameters Report- Device ID Information**  
**Image 2a**

- Interrogate the patient's device; Print the Parameters Report – Verify the Device ID listed at the bottom of the printout displays "Device Configuration ID: 1-0-0" or "Device Configuration ID: 1-1-0"; Refer to Images 2a and 2b in Appendix A.

- If the Parameters Report does not display the new Device ID number, verify that the correct software application has already been installed (SW040 Version 8.1).

- If the programmer has not been updated, install Software Application SW040 Version 8.1 and re-interrogate the patient's device.
  - If the programmer has been updated and the Device Configuration ID is not 1-0-0 or 1-1-0, the patient's device was unable to successfully receive the update. Contact Medtronic Technical Services for additional instructions.
