## SAFETY ALERT

### **Proper Connection of Sutureless Connector Intrathecal Catheters**

Catheter Models: 8709SC, 8731SC, 8596SC, 8578

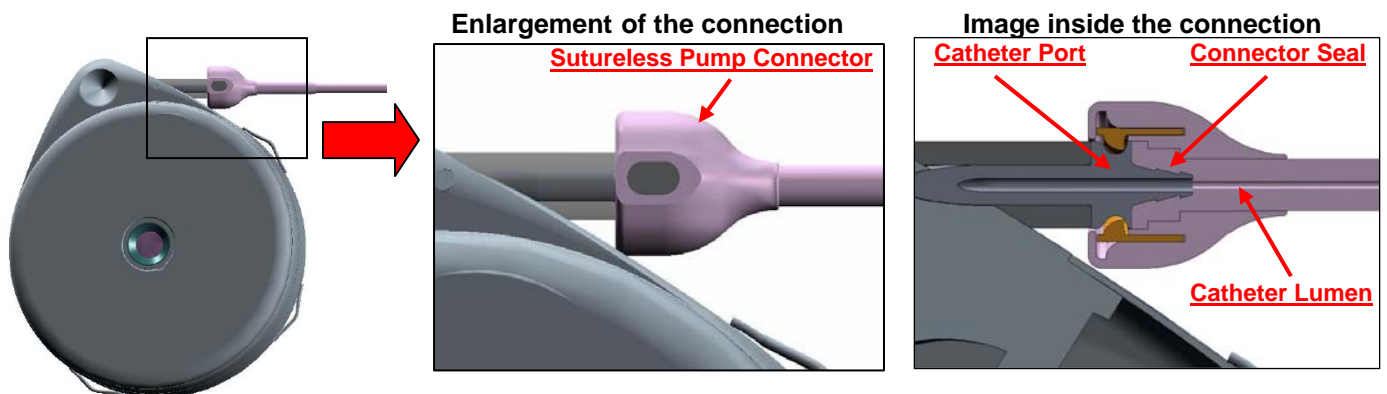
#### **Images of Correct SC Catheter Connection to the SynchroMed II Infusion Pump**

Medtronic has received reports of infusion system difficulties that have been attributed to occlusion between the sutureless pump connector and the catheter port, and disconnections of the sutureless pump connector from the catheter port. Medtronic investigation indicates these events are caused by misalignment or incomplete connection of the sutureless pump connector to the catheter port. Proper alignment and full engagement of the sutureless pump connector to the catheter port during attachment is critical in ensuring the catheter is properly and completely connected to the pump.

Proper alignment of the central axis of the sutureless pump connector to the central axis of the catheter port, in addition to full engagement of the sutureless pump connector to the catheter port are imperative in ensuring proper connection.

**Please refer to the enclosed *Recommendations for Implant Techniques* for detailed information on connecting the catheter to the pump and verifying proper attachment.**
