April 16, 2015

Urgent Medical Device Safety Notification

Important information regarding extension handling during implant procedure
Medtronic DBS Extensions Models 37085 and 37086

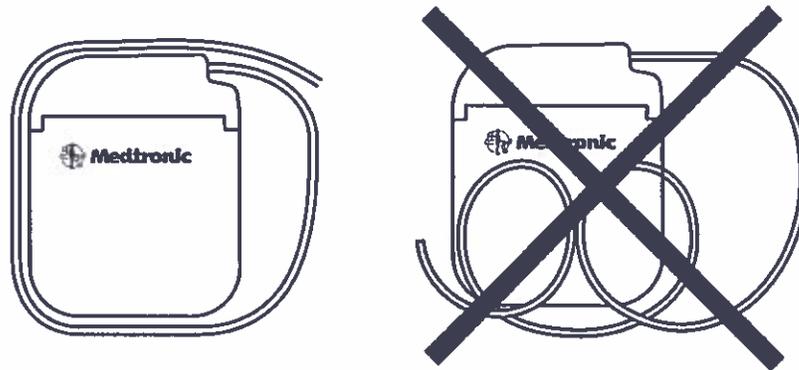
Figure 3. Wrap excess extension around the perimeter of the neurostimulator.

- Ensure that the neurostimulator is placed no deeper than 4 cm (1.5 in) below the skin and is parallel to the skin. If the neurostimulator is too deep or is not parallel to the skin, telemetry may be unsuccessful.
- Do not coil excess extension in front of the neurostimulator. Wrap excess extension around the perimeter (Figure 3) of the neurostimulator to minimize subcutaneous pocket depth, help minimize potential damage during neurostimulator replacement surgery, help minimize potential kinking of the extension, and minimize interference with telemetry. Excess extension should not exceed two wraps around the perimeter of the neurostimulator. Extension lengths requiring more than two wraps can interfere with telemetry.
