## 医疗器械主动召回通知函

Exacta 体外引流及监测系统三通阀可能存在裂痕和泄漏  
型号：46700、46705

# Exacta™ Medical Device Correction Letter Training

## Exacta™ 医疗器械纠正措施函培训

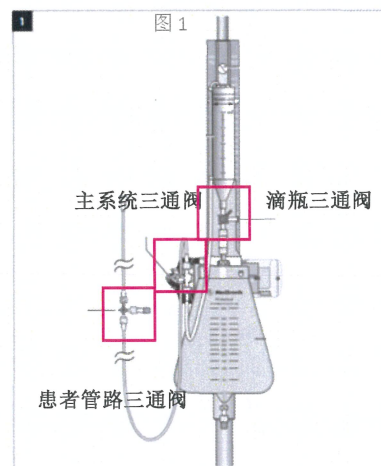
美敦力收到客户投诉，报告与 Exacta 体外引流及监测系统产品相关的三通阀裂痕和/或泄漏。在这些产品上，根据具体系统配置，三通阀可能位于系统的三个不同位置（参见图 1 中的 Exacta 系统示例）。三通阀的裂痕或泄漏会破坏引流系统的完整性，从而有可能导致感染的风险。已经报告了三起与患者感染相关的不良事件。

- 如果系统在使用过程中出现裂痕或泄漏，请使用无菌技术进行更换，并将损坏的系统退回美敦力。若泄漏发生在患者管路三通阀（见图1），在确认夹闭管路不会影响患者安全的前提下，可考虑在近端使用止血钳或其他夹钳临时夹闭管路，更换系统。
- 如产品标签所述，所有使用 **Exacta** 体外引流及监测系统的患者都应监测是否有感染迹象。如果发现系统有裂痕或泄漏，应更换系统，并继续监测患者是否有感染迹象。

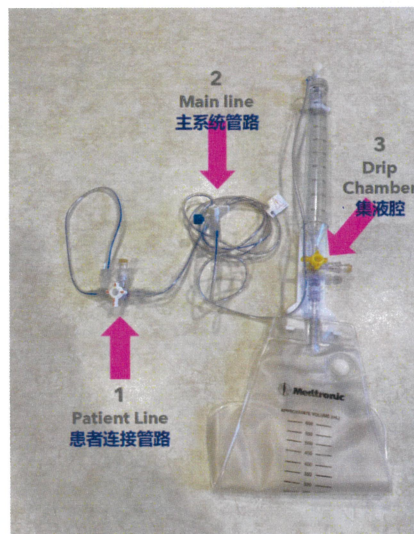
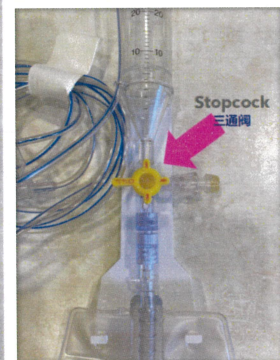
Medtronic has received customer complaints reporting cracks and/or leaks on the stopcock of Becker™ and Exacta™ EDMS devices.

On these devices, the stopcocks may be in **three** different locations in the EDMS, depending on the specific system configuration.

1. Patient line 患者连接管路
2. Main line 主系统管路
3. Drip Chamber 集液腔

Cracks or leaks of the stopcock can compromise line integrity and, as a result, present a potential for infection.

\*Enlarged image of stopcock  
三通阀的放大图像

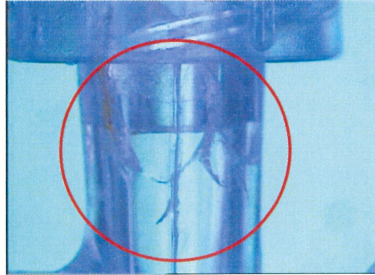
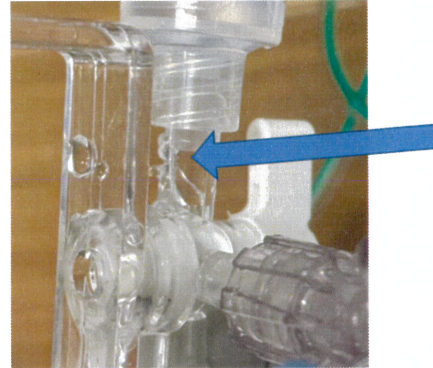
\*All images are examples of potential cracks.  
所有图像均为潜在裂痕的示例

1. Prior to use, inspect all stopcocks and connections to ensure that connections are secure and that there are no visible cracks in the stopcocks.  
使用前，检查所有三通阀及其连接，确保连接牢固且三通阀无可见裂痕。

2. If cracks or leaks are identified, do not use the device and return it to Medtronic.

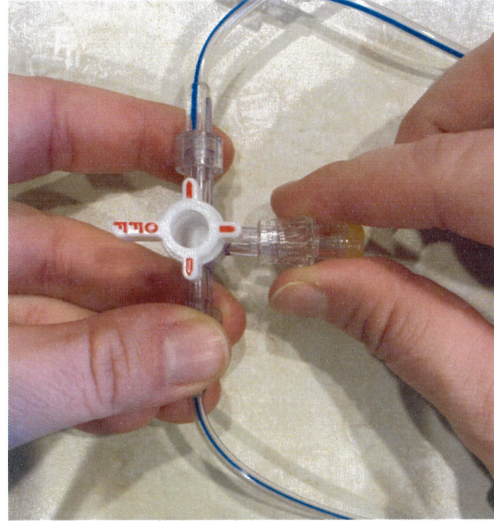
Over tightening can cause cracks and leaks to occur.

5. All connections should be **finger tightened**. Do not use any instruments to tighten.

6. Whenever cleaning with alcohol, or a disinfectant containing alcohol, **allow cleaned components to air dry completely** prior to connecting the system.
