MEDTRONIC NAVIGATION, INC.

URGENT: VOLUNTARY MEDICAL DEVICE CORRECTION

O-arm™ O2 Imaging System Detector Panel Firmware Update

May 2026

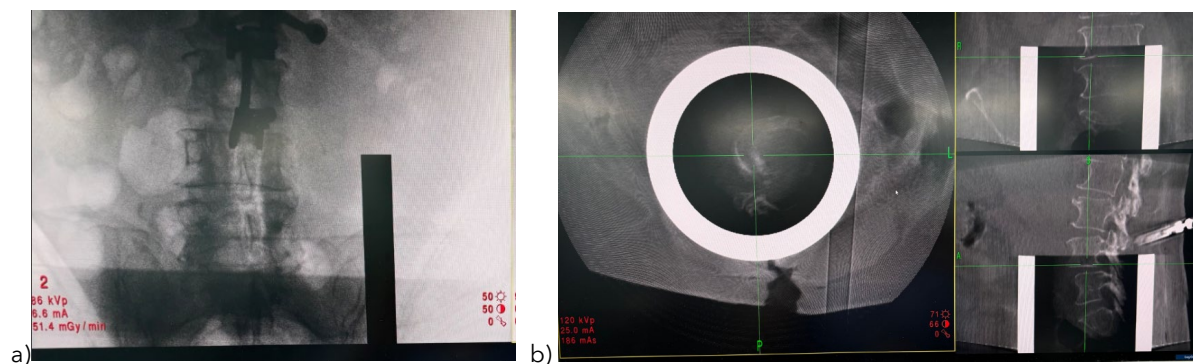
Medtronic has identified the potential for image artifacts caused by an anomaly in the O-arm O2 Imaging System's detector panel firmware.

The issue presents as an artifact in both 2D and 3D images and can be resolved by power cycling (rebooting) the system. If the artifact is present in a 2D image and the user proceeds to a 3D scan without rebooting the system, the artifact will persist in the 3D images as shown in the images in Figure 1 below.

Figure 1. Example of ASIC image artifacts. (a) 2D scan with rectangular artifact (b) 3D Scan with ring artifact

- Please complete and return the Customer Confirmation Form enclosed with this letter, acknowledging that you have received this information. The form may be emailed to neuro.quality@medtronic.com.
- You may continue use of the system prior to service by Medtronic to update the firmware. The issue is intermittent and may not present, however if it does it can be resolved by power cycling (rebooting) the system.
- A Medtronic Field Service Engineer will contact your facility to schedule time to update the firmware on your system to permanently resolve this issue.
- This notice should be passed on to those who need to be aware within your organization or to any organization where the affected devices have been transferred.
- Please maintain a copy of this notice in your records.
