### Urgent Medical Device Correction

#### HeartWare™ Ventricular Assist Device (HVAD™)

April 2022

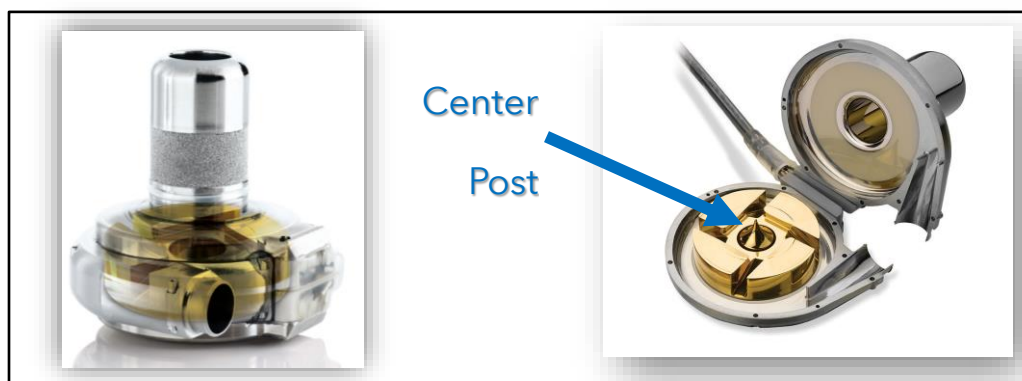
**Figure 1: Pump Assembly**

Medtronic is writing to inform you that we are investigating a new issue with the HeartWare™ Ventricular Assist Device (HVAD™) System. Medtronic has received three (3) complaints of patients with suspicion of pump thrombosis; however, a device malfunction was identified upon inspection of the three (3) returned pumps. Wear marks indicated that the impeller was rotating non-concentrically and contacting the center post of the pump (see Figure 1 Pump Assembly). The ongoing investigation suggests this was caused by a weld defect that allowed moisture into the center post and corroded the magnets that keep the impeller rotating concentrically.

These three pumps were manufactured between December 2017 and May 2018. A pump exchange was performed for all three patients. The time between initial presentation and pump exchange was five days for two (2) patients and five months for one (1) patient. One (1) patient was subsequently transplanted two months after the pump exchange and died one month later; one (1) additional patient died three weeks after the VAD exchange.

Routine prophylactic explant of the HVAD device is not recommended, as risks associated with explantation may outweigh the potential benefits. Physicians should make the decision regarding explant and exchange of the HVAD pump on a case-by-case basis (is the patient a candidate for pump exchange, heart transplant, or pump explant for recovery), considering the patient's clinical condition and surgical risks.

For patients presenting with any of the above signs and symptoms consider whether the clinical presentation could be due to a pump thrombus and treat accordingly. Please ensure the .csv logfiles are submitted to Medtronic for review.
