# Medtronic

### URGENT: MEDICAL DEVICE COMMUNICATION

#### HeartWare™ Ventricular Assist Device (HVAD™) System: Communication update regarding failure/delay to restart pump events

August 23, 2023

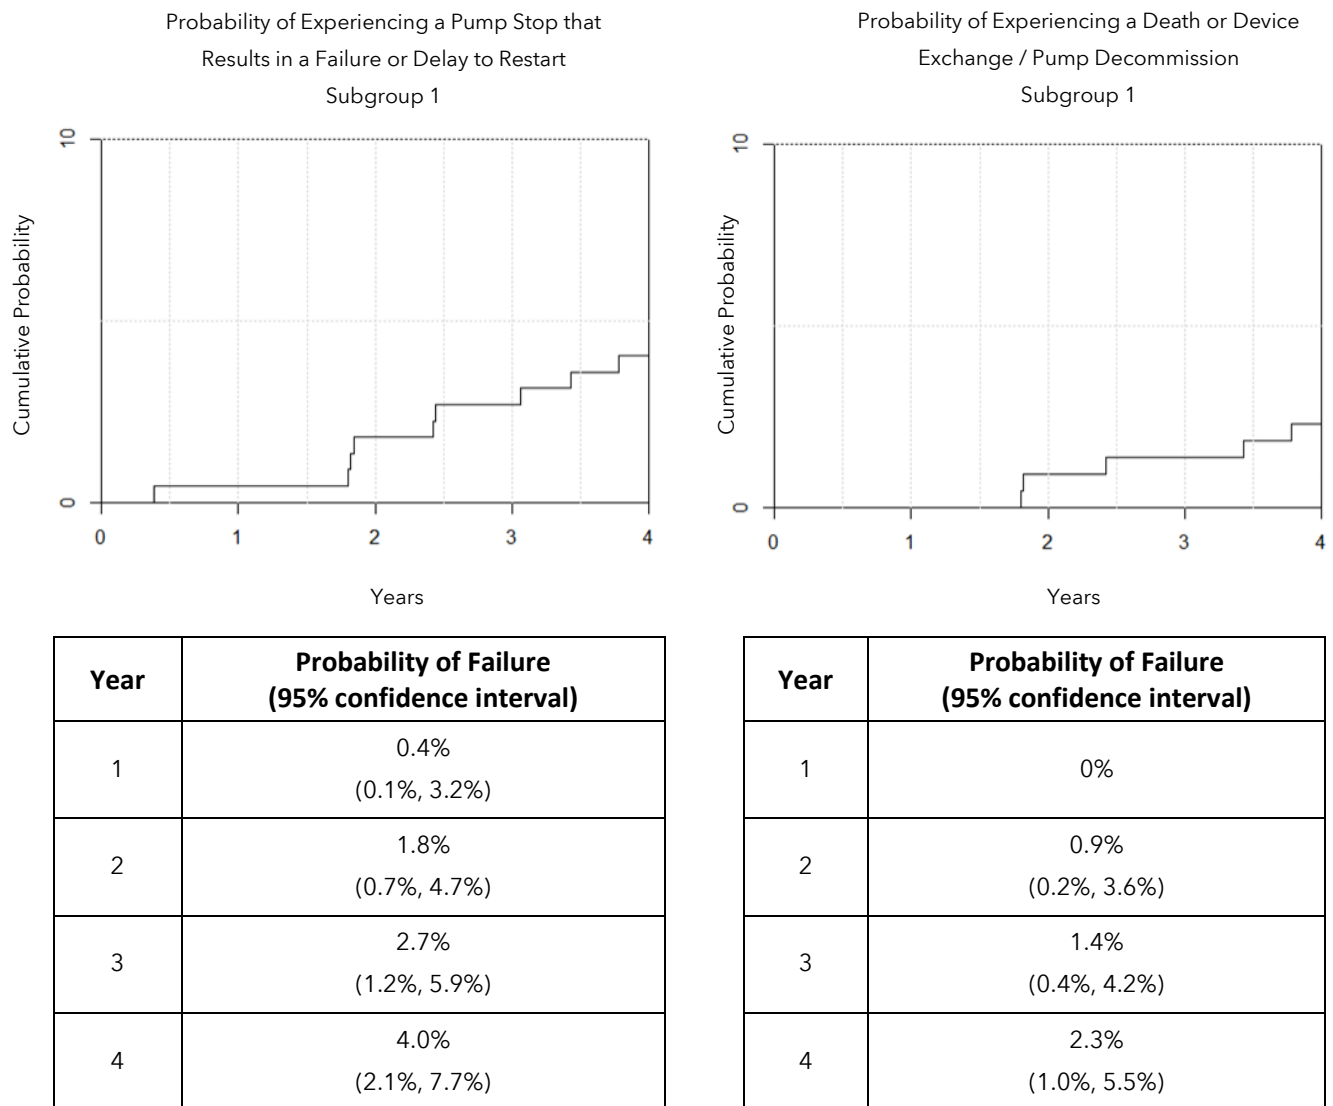
**Figure 1: Cumulative incidence of experiencing a pump stop with delay/failure to restart (left) and the cumulative incidence of failures leading to a pump exchange or death (right) in Subgroup 1.**

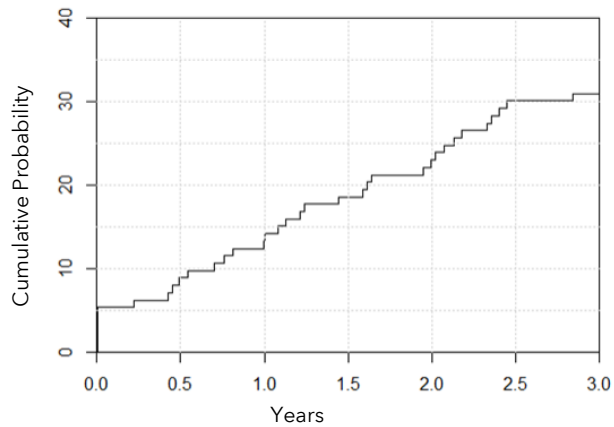
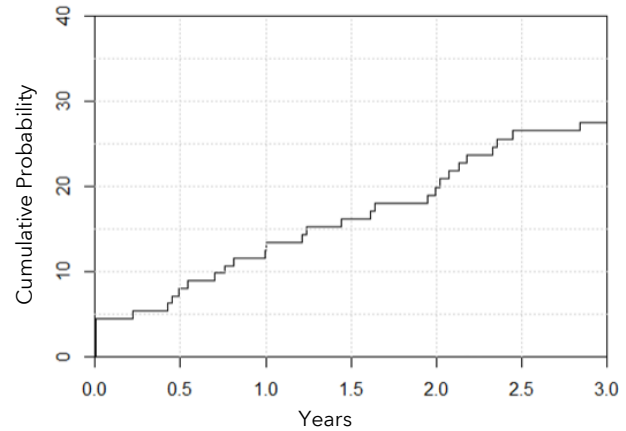
Probability of Experiencing a Pump Stop that  
Results in a Failure or Delay to Restart  
Subgroup 2

Probability of Experiencing a Death or Device  
Exchange / Pump Decommission  
Subgroup 2

**Figure 2: Cumulative incidence of experiencing a pump stop with delay/failure to restart (left) and the cumulative incidence of failures leading to a pump exchange or death (right) in Subgroup 2.**

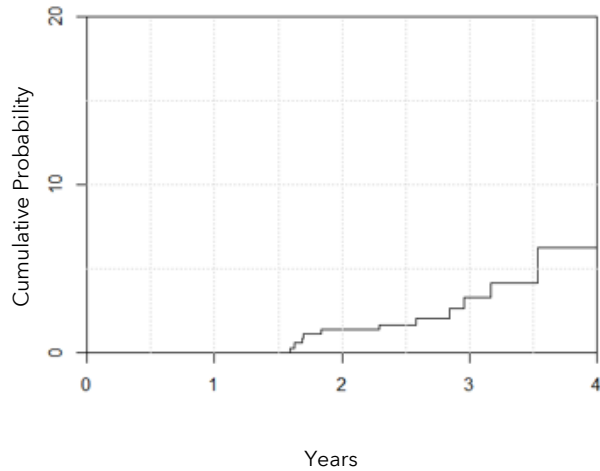
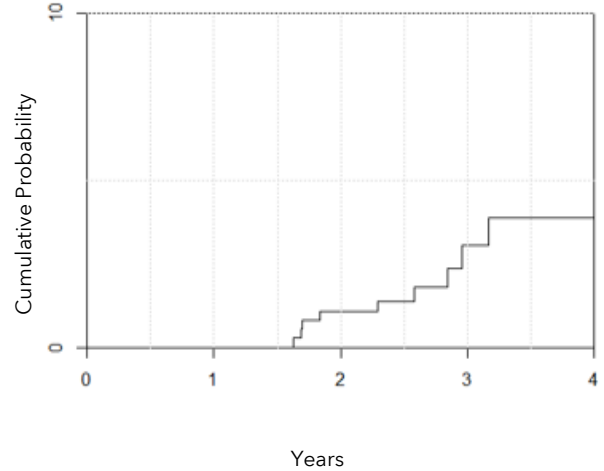
Probability of Experiencing a Pump Stop that  
Results in a Failure or Delay to Restart  
Subgroup 3

Probability of Experiencing a Death or Device  
Exchange / Pump Decommission  
Subgroup 3

**Figure 3: Cumulative incidence of experiencing a pump stop with delay/failure to restart (left) and the cumulative incidence of failures leading to a pump exchange or death (right) in Subgroup 3.**

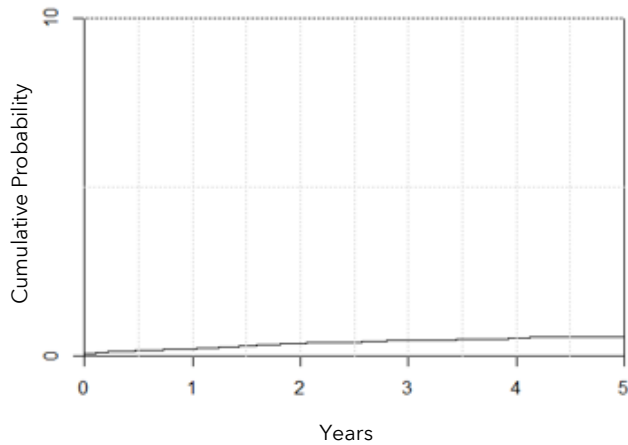
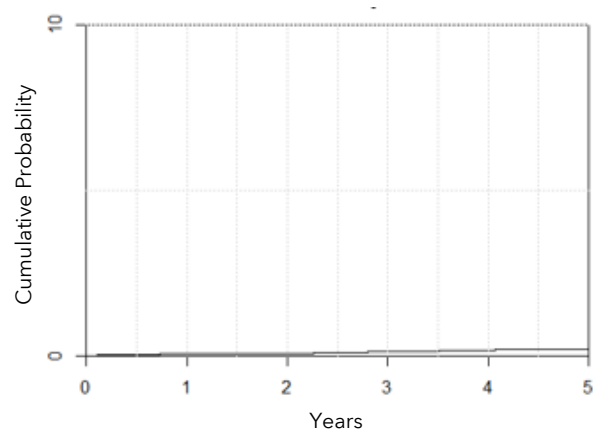
Probability of Experiencing a Pump Stop that  
Results in a Failure or Delay to Restart  
General Population

Probability of Experiencing a Death or Device  
Exchange / Pump Decommission  
General Population

**Figure 4: Cumulative incidence of experiencing a pump stop with delay/failure to restart (left) and the cumulative incidence of failures leading to a pump exchange or death (right) in the general population.**
