## URGENT MEDICAL DEVICE COMMUNICATION

### HeartWare™ Ventricular Assist Device (HVAD™) System

December 2021

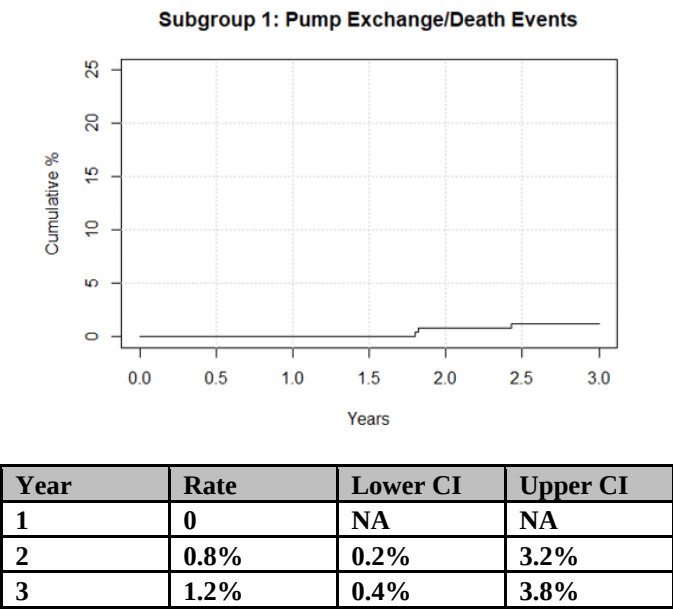
**Figure 1: Cumulative incidence of experiencing a pump stop with delay/failure to restart leading to a pump exchange or death in Subgroup 1**

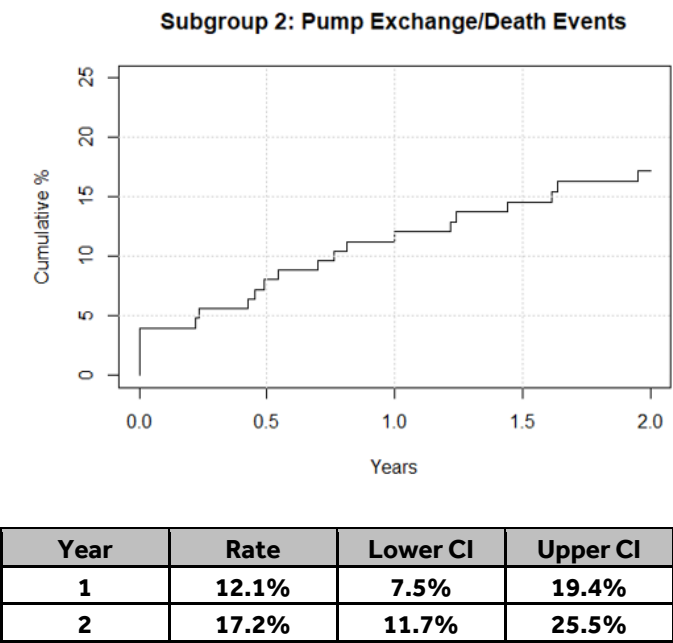
**Figure 2: Cumulative incidence of experiencing a pump stop with delay/failure to restart leading to a pump exchange or death in Subgroup 2**
