## Urgent Medical Device Correction

### Pump Weld Update for HeartWare™ Ventricular Assist Device (HVAD™)

26 July 2022

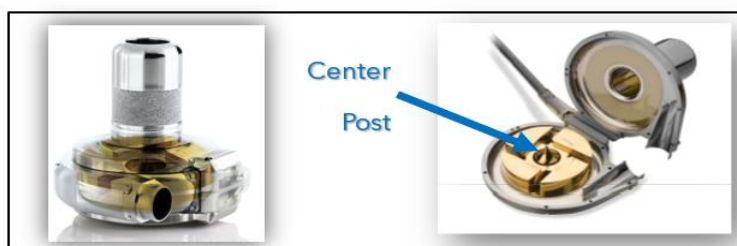
**Figure 1: Pump Assembly**

Medtronic is providing this letter as a follow-up to our April 2022 communication titled "Urgent Medical Device Correction" (attached), which communicated a pump weld non-conformance with the HeartWare™ Ventricular Assist Device (HVAD™) System where (3) pumps were identified to have an impeller rotating non-concentrically and contacting the center post of the pump (see Figure 1: Pump Assembly). Medtronic's investigation was not able to conclusively isolate this issue to a specific subset of pumps. This communication provides updated information on the number of events, additional event details, and root cause.

The investigation has determined that the occurrence of a weld crack is the result of a combination of factors that may include the initial presence of contamination in the weld area from previously applied substances as part of the manufacturing process, the misalignment of the cap and housing prior to welding, or the depth/thickness of the weld. Medtronic's investigation employed multiple methods to isolate the issue to a specific subset of pumps including quantifying weld thickness, alignment indicators, and visual indications of contamination using over 8000 digital photos. Medtronic has found that there is not enough data available to conclusively isolate this issue to a specific subset of pumps.

Consistent with the April 2022 communication, routine prophylactic explant of the HVAD device is not recommended, as risks associated with explantation may outweigh the potential benefits. Physicians should make the decision regarding explant and exchange of the HVAD pump on a case-by-case basis (is the patient a candidate for pump exchange, heart transplant, or pump explant for recovery), considering the patient's clinical
