URGENT: MEDICAL DEVICE CORRECTION

Becker and Exacta External Drainage and Monitoring Systems
Potential for Stopcock Cracking and Leaking

07 November 2024 | 20:09 SGT

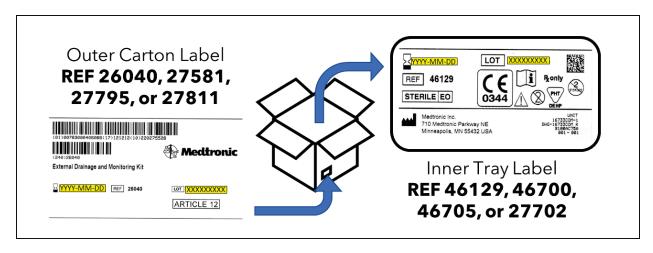
Below is an example of outer carton and inner tray labeling configurations:

Figure 2 - Becker/Exacta EDMS Kit (outer carton) and Becker/Exacta EDMS Device (inner tray)

Note: Kitted products may possess two CFNs, and the contents of the outer carton might have been removed and stored independently in the hospital inventory. The table above contains all CFNs (both outer carton and inner tray). Even if product is removed and stored outside of the outer carton, the listing above is inclusive of all impacted EDMS CFNs.
