URGENT MEDICAL DEVICE CORRECTION**Medtronic HeartWare™ HVAD™ System**

May 2018

HVAD System with Controller 1.0 - Identifying Unexpected Power Source Switching Behaviors

HVAD System with Controller 2.0 - Identifying Unexpected Power Source Switching Behaviors

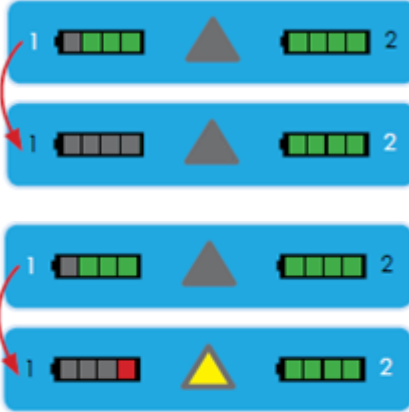
Replace the first battery and remove from service.
There is a sudden change in charge capacity on a battery (for example, a sudden change from 3 LEDs to 0 LEDs, or from 3 LEDs to 1 LED).

Replace the abnormally behaving battery and remove from service.
"Beeping" and the controller rapidly switches back and forth between batteries.

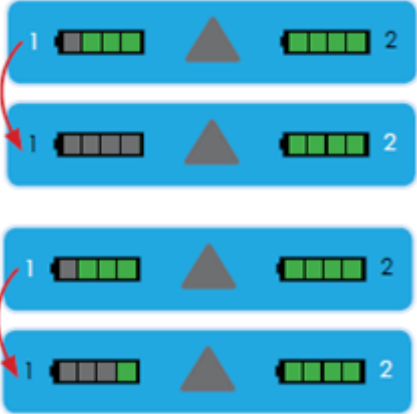
Replace the first battery and remove from service.
There is a sudden change in charge capacity on a battery (for example, a sudden change from 3 LEDs to 0 LEDs, or from 3 LEDs to 1 LED).

Replace the abnormally behaving battery and remove from service.
"Beeping" and the controller rapidly switches back and forth between batteries.
